Inspection Sample

11111 abcde Rd

WHAT REALLY MATTERS IN A HOME INSPECTION

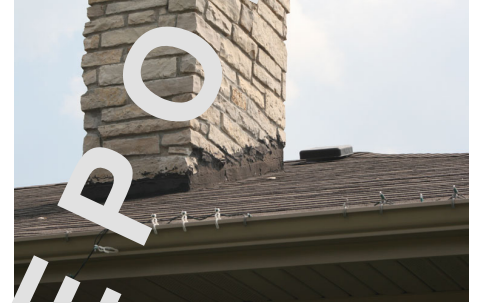
4.5.1 - Mastic covered flashing on chimney. *

There were no signs of a leak at the time of inspection but it will require regular maintaine in order to keep it water tight. There is no counter flashing over the step flashings. The step flashing was covered with tar. The Home Inspector recomends a proper flashing be installed.

The step flashings are covered with tar. There are no signs of water leaking into the structure at the time of inspection. The Home Inspector recommends a proper flashing be installed.

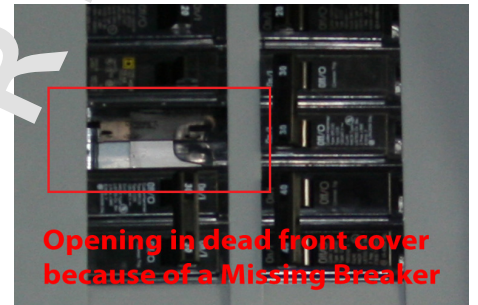
7.4.1 - Openings in deadfront cover for the sub-panel. 2 4

There is an opening in the dead front cover for this sub-panel due to a missing breaker. The Neutral and Ground wires are bonded in this sub-panel. This is a safety hazard and needs to be corrected to avoid injury.

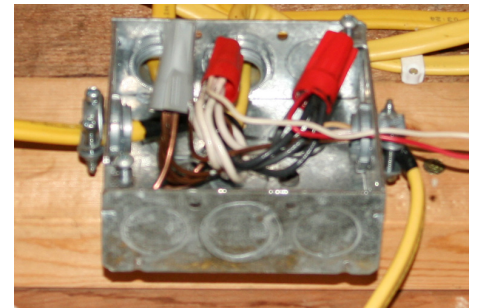
7.5.1 - Missing/damaged junction box cover plates. * 4

Box cover is missing and exposed wiring needs protection. This is located in the basement on floor joist near the sub-panel. This is a safety hazard!

See Image Summary 7.5.1 - Location for missing cover and exposed wiring is in the basement on the floor joist near the sub-panel on the south wall.

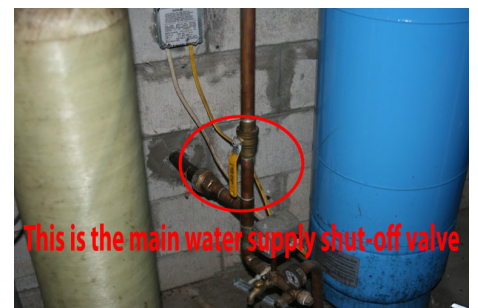
5.1.1 - Main water supply shut off valve

This is the shut-off valve for the main water supply to this house. It is located in the basement on the South Wall.

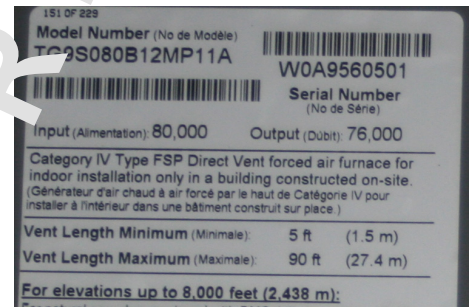
6.1.1 - Furnace Tag

Brand: Unknown
Manufacture Date: Unknown
Output: 76000 BTU
Model: TG9S080B12MP11A
Serial No: W0A9560501

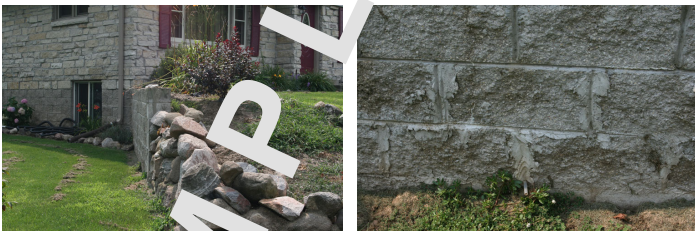
1.3.1 - Retaining Walls

There is a retaining wall on east side of the property.

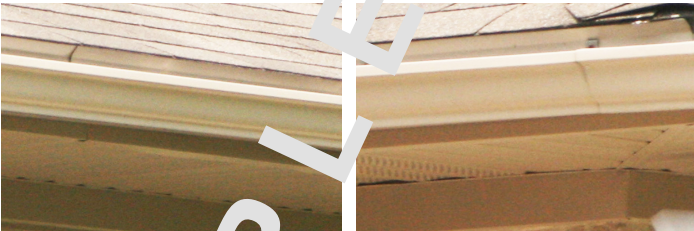
2.3.1 - Trim

Metal trim and soffit system - over wood fascia.

All trim appeared to be in good condition at the time of inspection.

Inspector is unable to determine the condition of wood fascia and trim behind metal wrapping.

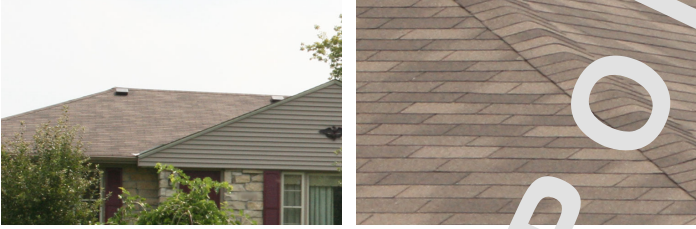
4.2.1 - Roof - Asphalt composition - Wood

The home has a combination of gable and hip roofs. The main roof was a hip roof

Roof components appeared to be in serviceable condition at the time of the inspection.

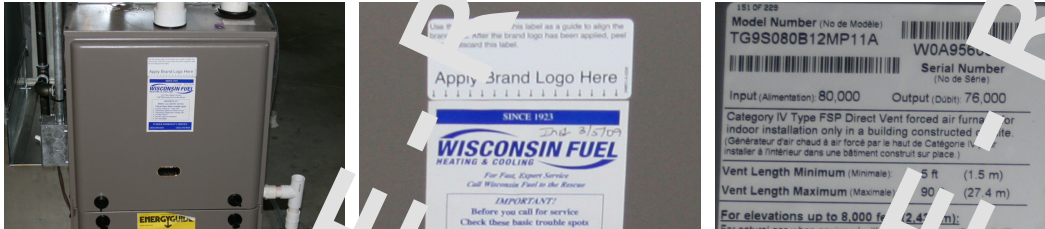
6.1.1 - Heating System

The heating system is located in the basement.

Burner flame appears proper.
